RE: NL Industries/Taracorp Superfund Site; Granite City, Illinois
Operation and Maintenance Inspection (March 22, 2004)

**NL Industries/Taracorp Superfund Site
O & M Inspection Log**

NL/Taracorp Site
O&M Inspection Photographs
March 22, 2004

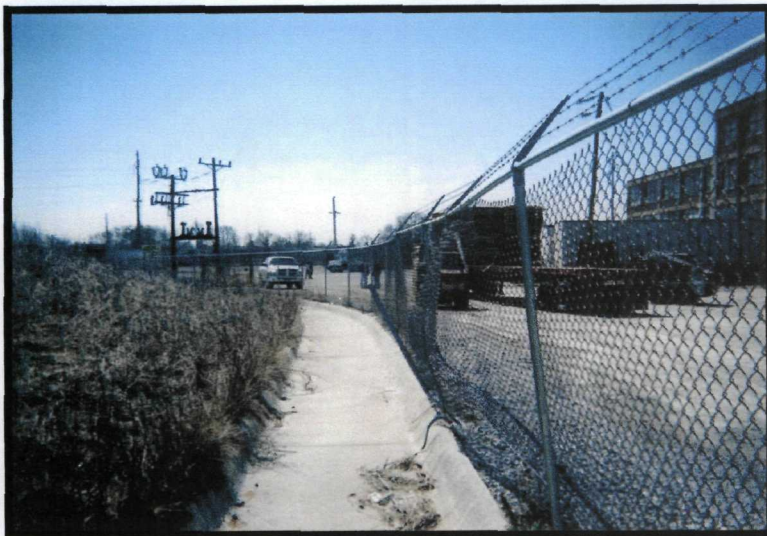
| Site Structure | Inspected (Yes/No) | Inspection Observations | Maintenance Work Required or Performed |
|---|---|---|---|
| • Comments | | Fence pole bent on west side. May have been backed into from neighboring operations. No breach or damage to the fence fabric. | Check condition during next inspection |

Photograph 1
Concrete drainage channel at southwest corner of site, damaged fence and pole

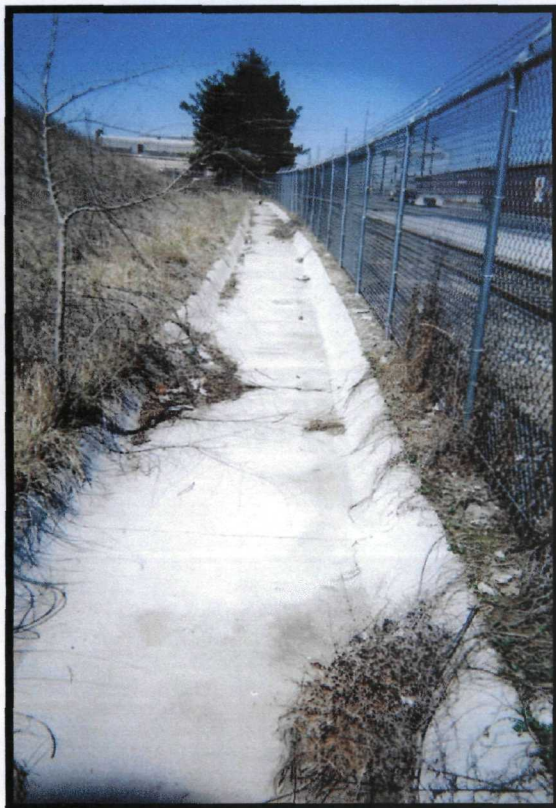
| Site Structure | Inspected (Yes/No) | Inspection Observations | Maintenance Work Required or Performed |
|--|---|---|--|
| • Evidence of cracks or obstructions | Y | No visible cracks. Minimal obstructions from erosion/run-off sediment. (see photos) | Recommend sweeping/pressure washing of concrete channel after erosion repair are made. |

Photograph 2
Concrete drainage channel along north side of site

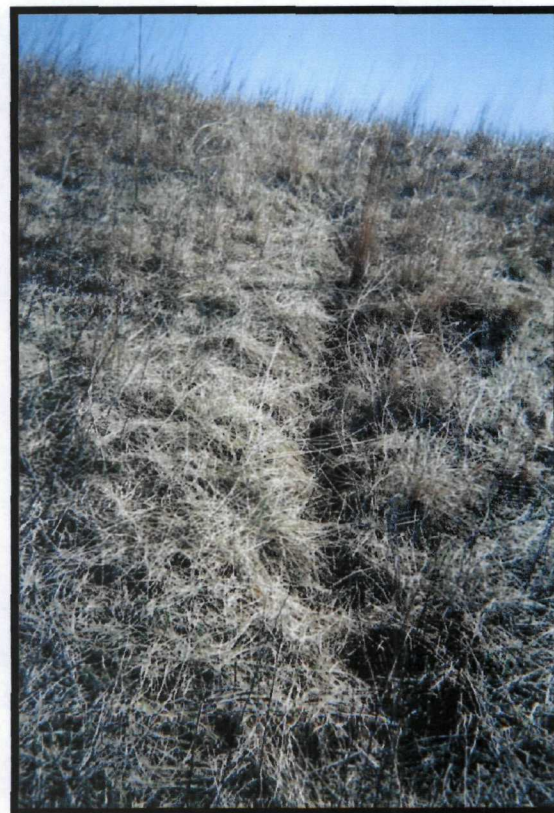
| Site Structure | Inspected (Yes/No) | Inspection Observations | Maintenance Work Required or Performed |
|---|---|---|---|
| • Indicate areal extent and location | | 6 locations on west side slope with erosion from top of slope to mid slope or toe of slope. | Recommend maintenance to prevent further erosion. |
| • Indicate areal extent and location | | Most severe erosion on the west side slope from top of slope down to concrete channel. | Recommend maintenance to prevent further erosion. |

Photograph 3
Taracorp pile cap,
middle of west side slope erosion

As you know, the Group has authorized ENTACT to perform maintenance activities at the site. ENTACT is scheduled to repair the erosion areas on the Taracorp pile cap as soon as weather conditions allow ENTACT to perform that work.

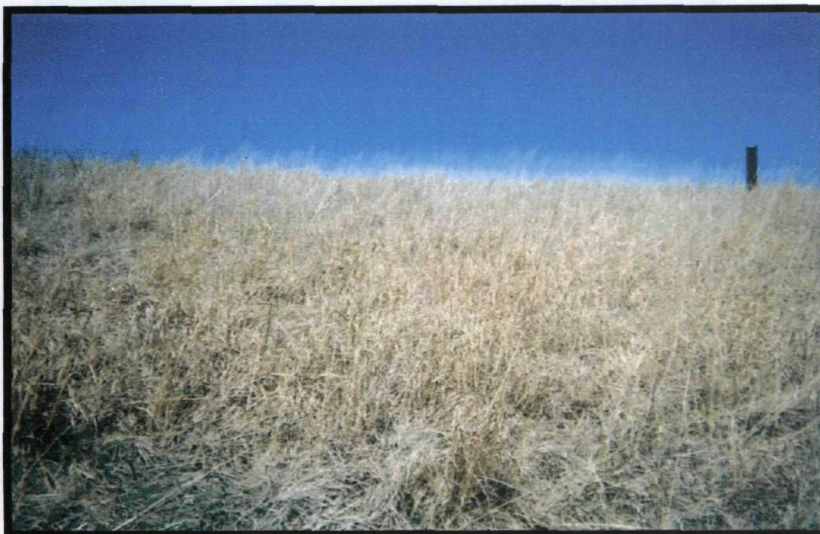
Photograph 4
Taracorp pile cap,
middle of east slope,
toe to top

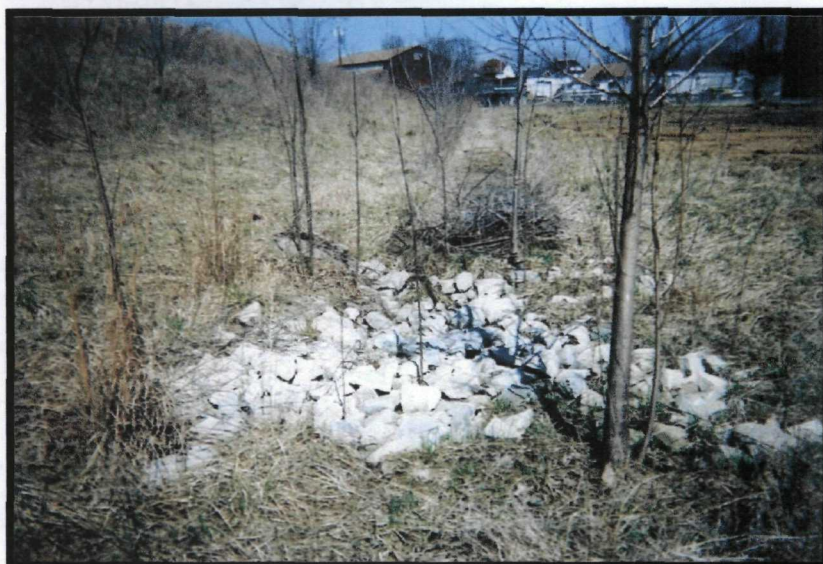
Photograph 5
Rip rap at end of
drainage channel at
northeast corner of site

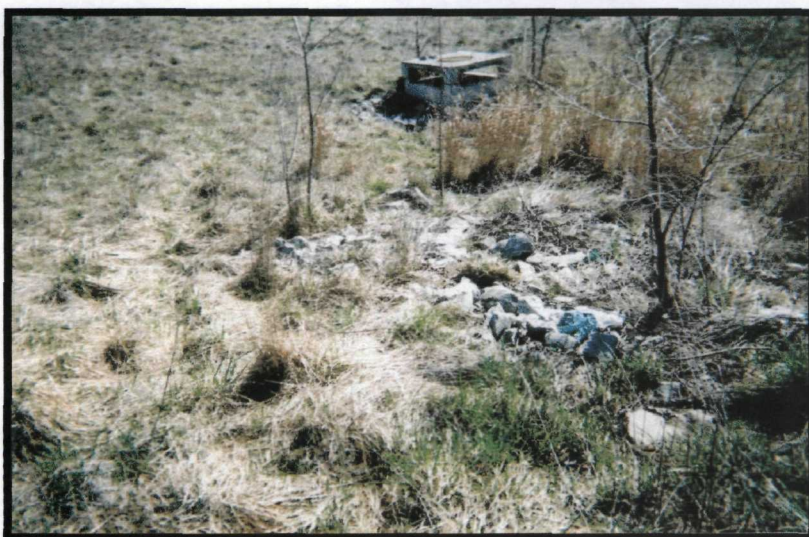
Photograph 6
Rip rap at end of
drainage channel at
southeast corner of
site

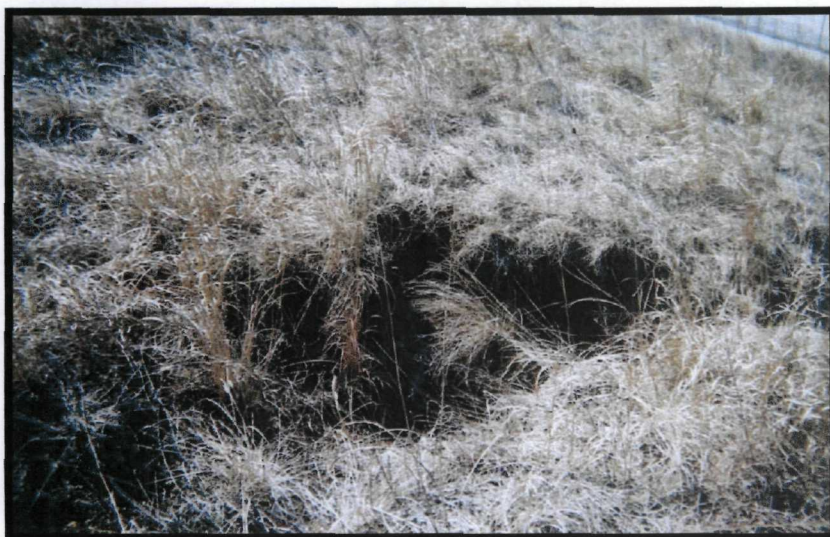
| Site Structure | Inspected (Yes/No) | Inspection Observations | Maintenance Work Required or Performed |
|---|---|---|---|
| • Evidence of cracks | Y | Erosion listed above. Erosion crack widths vary from 6 inches to 12 inches and depths of 6 inches to 36 inches. | Recommend maintenance to prevent further erosion. |

Photograph 7
Taracorp pile cap,
southwest side slope
erosion

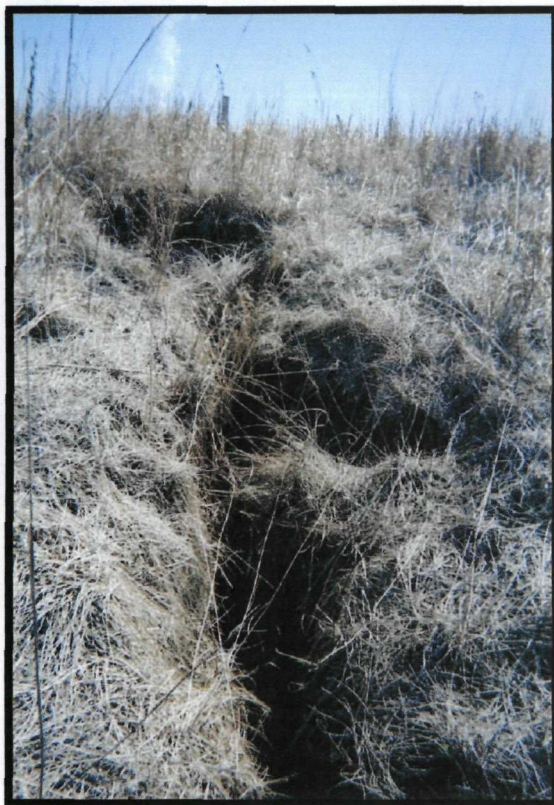
Photograph 8
Taracorp pile cap,
Southwest side slope erosion 2

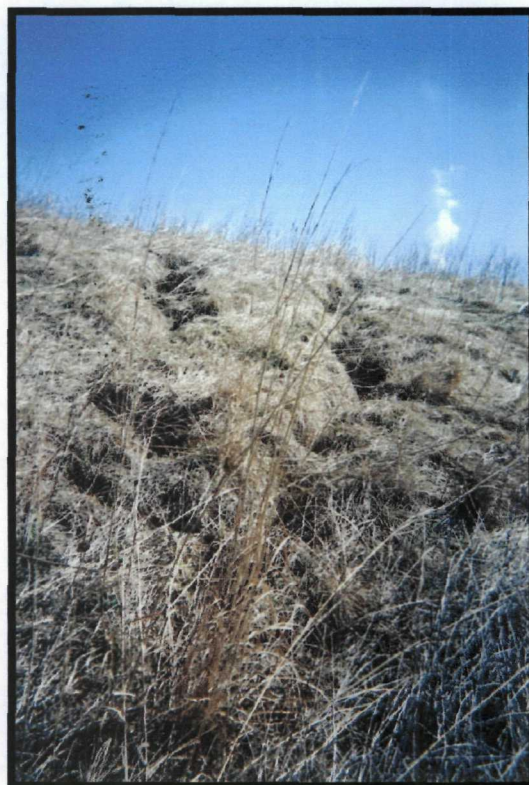
Photograph 9
Taracorp pile cap,
southwest side slope erosion 3

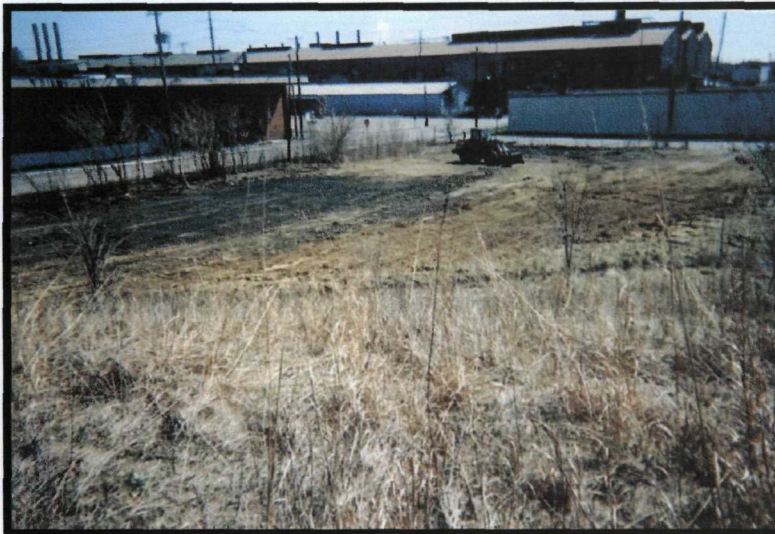
Photograph 10
Top of cap facing
northeast corner of site
(showing area where
former BV&G Trucking
buildings were demolished)

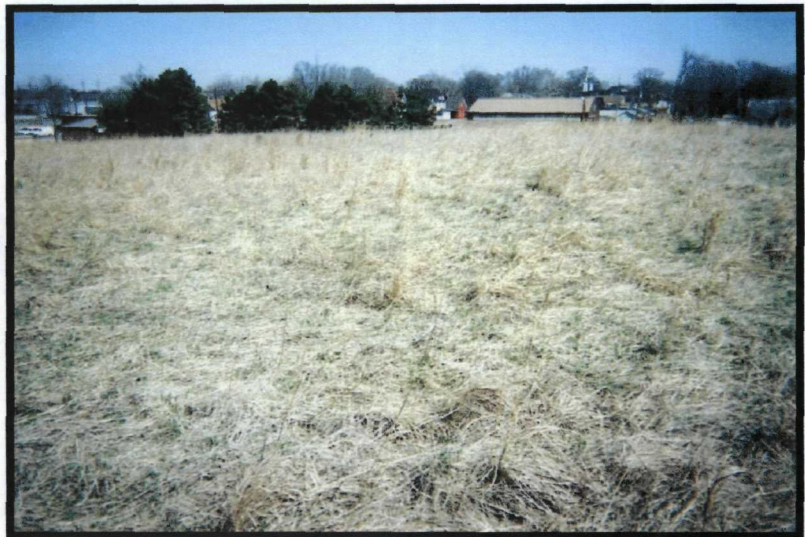
Photograph 11
Taracorp pile cap,
top of cap facing north

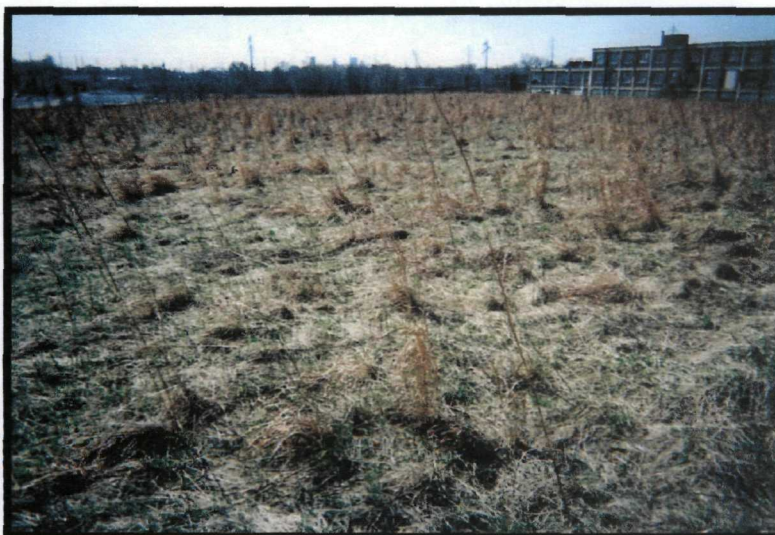
Photograph 12
Taracorp pile cap,
top of cap facing south

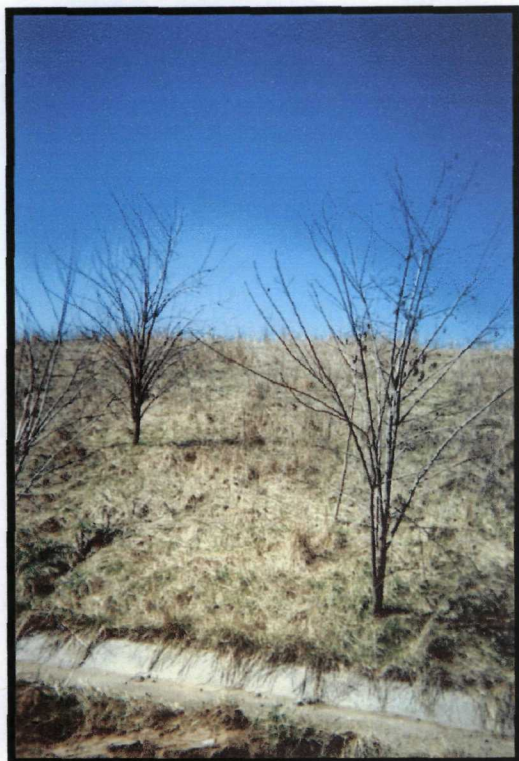
| Site Structure | Inspected (Yes/No) | Inspection Observations | Maintenance Work Required or Performed |
|---|---|---|---|
| • Presence of trees/shrubs | Y | Some small trees on northeast corner. See photos | |

Photograph 13
Taracorp pile cap,
tree growth on northeast corner

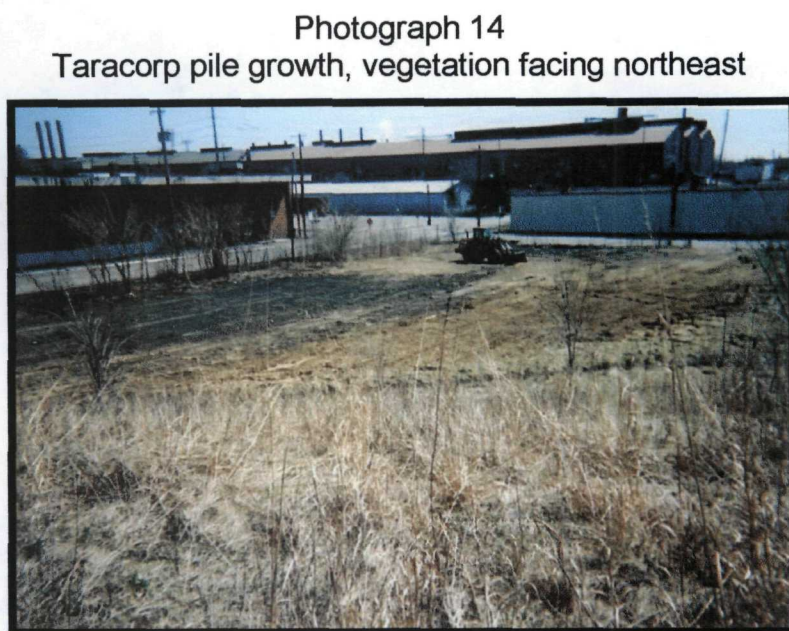
Photograph 14
Taracorp pile growth, vegetation facing northeast

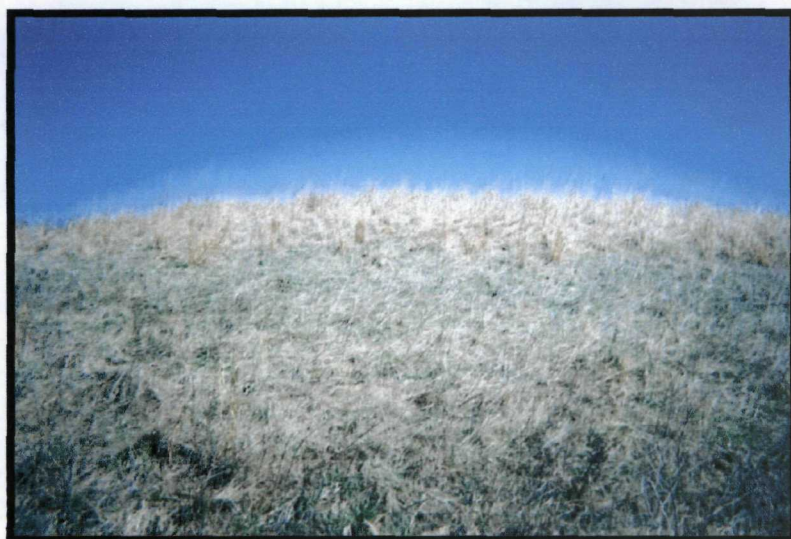
Photograph 15
Taracorp pile cap,
vegetation on south slope

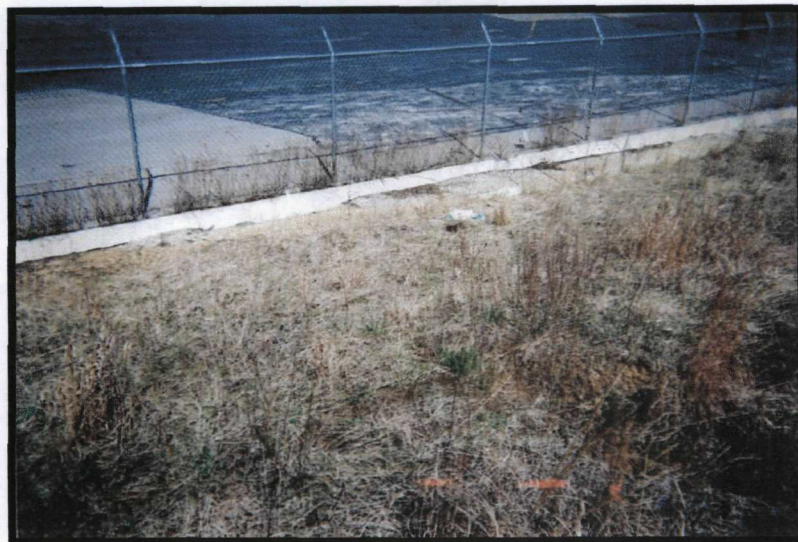
**Photograph 16
Taracorp cap, west slope erosion
and sediment in concrete drain**
